# Poročilo o preskusu / Test Report

T211-0395R/12

<b>Proizvod / Product</b> Heating element Model: 12/18/6000 Ratings: 230 V; 50 Hz; 1800-2400 W; IP65; class I	<b>Listov / Pages</b> 9
<b>Naročnik / Applicant</b> ELMERA Elektromehanički obrt za izradu svih vrsta grijača Ivanec, Gorica 34, 10290 Zaprešić, Croatia	<b>Vrsta preskusa / Test procedure</b> Vibration, shock and IK10 test
<b>Proizvajalec / Manufacturer</b> ELMERA Elektromehanički obrt za izradu svih vrsta grijača Ivanec, Gorica 34, 10290 Zaprešić, Croatia	<b>Št. Merjencev / No. of Items tested</b> 1
<b>Blagovna znamka / Trade Mark</b> ELMERA	<b>Mapa predmeta št. / Subject File No.</b> C20121524
<b>Standardi – predpisi / Standards - regulations</b> EN 50125-3:2003, clause 4.13.1 and 4.13.2 EN 50102:1995/A1:1998	<b>Kraj preskusa / Place of test</b> SIQ, Tržaška 2 Ljubljana, Slovenia
	<b>Opomba / Remark</b> /

Heating element, model 12/18/6000 was subjected to the vibration and shock test according to standard EN 50125-3:2003 clauses 4.13.1 and 4.13.2 and IK10 test (degree of protection provided by enclosures of electrical equipment against external mechanical impacts) according to standard EN 50102:1995/A1:1998.

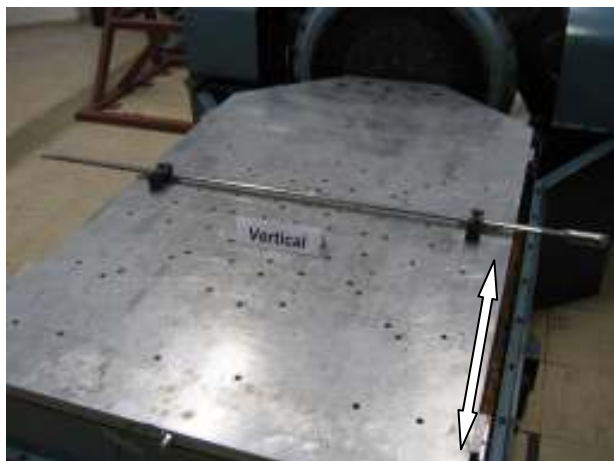
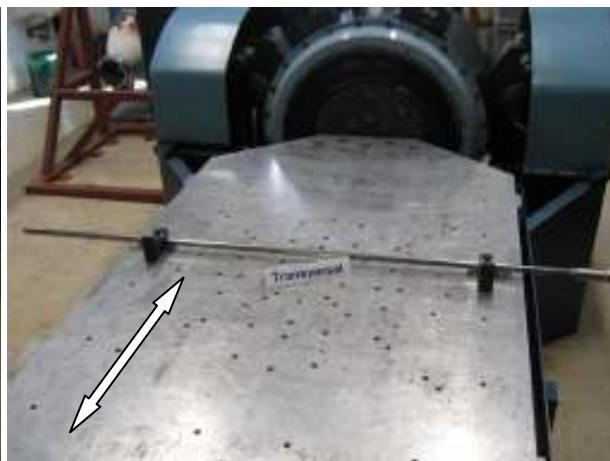
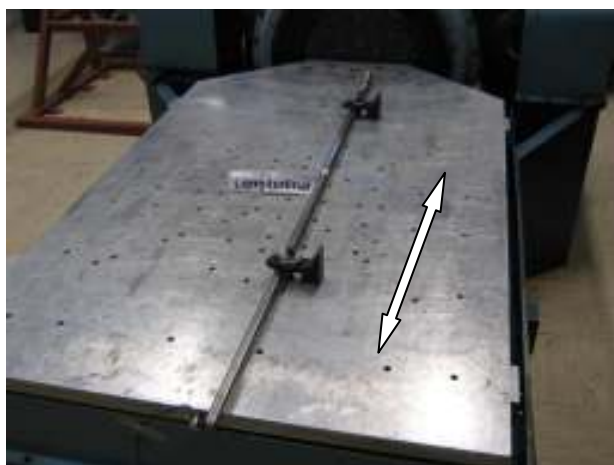
The fixation of the EUT on the electro-dynamic shaker VP700 in vertical, transversal and longitudinal axis is shown in Figures 1 to 3.

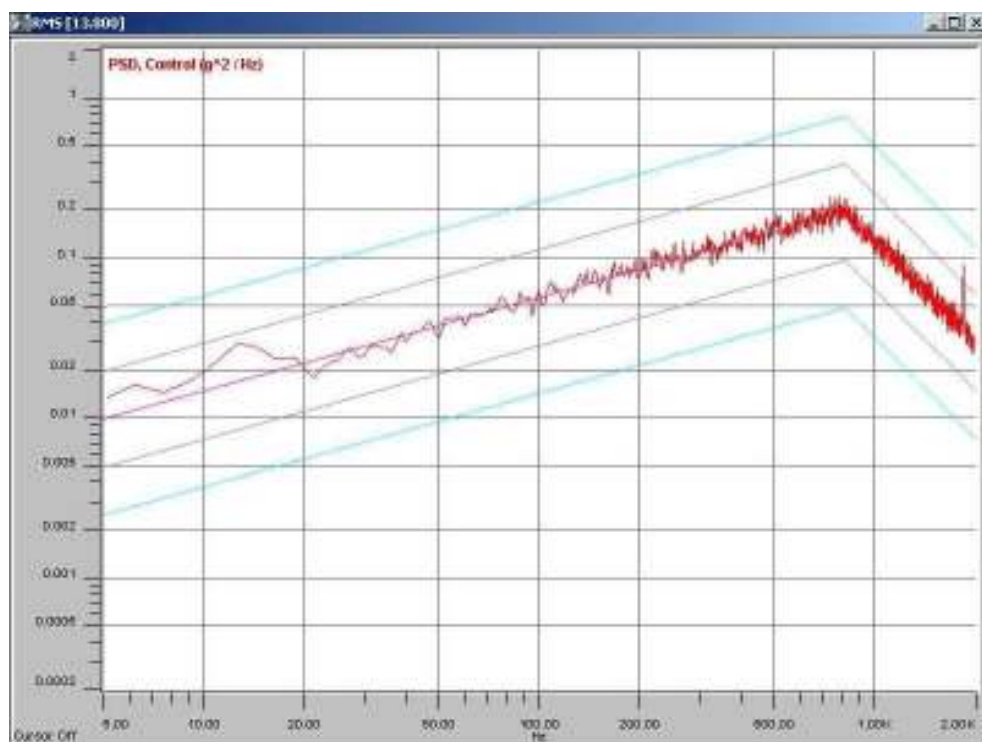
Figure 4

- Environmental temperature 24<sup>0</sup>C,
- Total frequency range: 5 ÷ 2000 Hz,
- Frequency 5 Hz: Accel. Spectral. Density: 1.0 (m/s<sup>2</sup>)<sup>2</sup>/Hz,
- Frequency 820 Hz: Accel. Spectral. Density: 20 (m/s<sup>2</sup>)<sup>2</sup>/Hz,
- Frequency 2000 Hz: Accel. Spectral. Density: 2.0 (m/s<sup>2</sup>)<sup>2</sup>/Hz,
- RMS value of acceleration: 130 m/s<sup>2</sup>,
- Duration of the test: 5 hours

The random vibration profile is presented in a diagram (Figure 4).

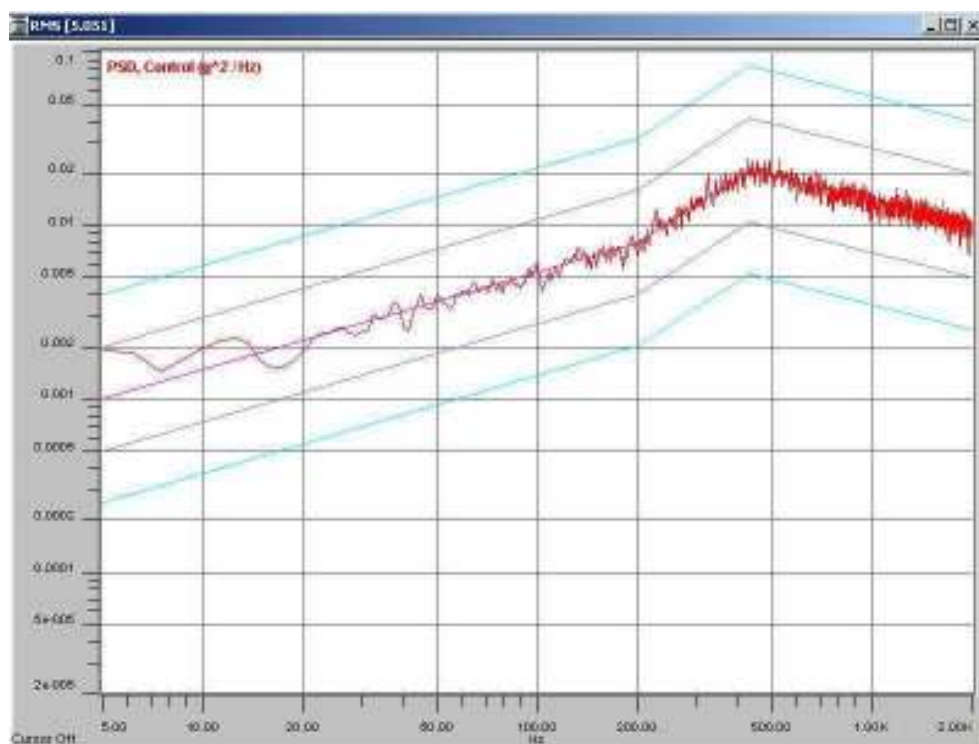
Figure 5

- Environmental temperature 24<sup>0</sup>C,
- Total frequency range: 5 ÷ 2000 Hz,
- Frequency 5 Hz: Accel. Spectral. Density: 0.1 (m/s<sup>2</sup>)<sup>2</sup>/Hz,
- Frequency 200 Hz: Accel. Spectral. Density: 0.8 (m/s<sup>2</sup>)<sup>2</sup>/Hz,
- Frequency 430 Hz: Accel. Spectral. Density: 2.2 (m/s<sup>2</sup>)<sup>2</sup>/Hz,
- Frequency 2000 Hz: Accel. Spectral. Density: 1.0 (m/s<sup>2</sup>)<sup>2</sup>/Hz,
- RMS value of acceleration: 50 m/s<sup>2</sup>,
- Duration of the test: 5 hours

The random vibration profile for transversal axis is presented in a diagram (Figure 5).

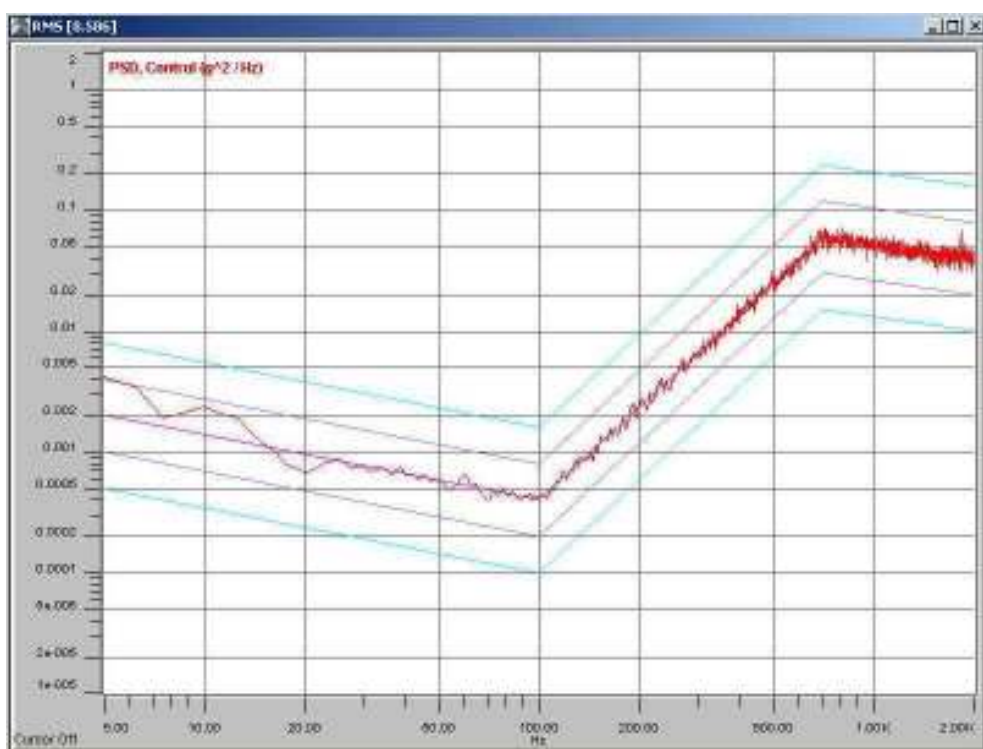
Figure 6

- Environmental temperature 24<sup>0</sup>C,
- Total frequency range: 5 ÷ 2000 Hz,
- Frequency 5 Hz: Accel. Spectral. Density: 0.2 (m/s<sup>2</sup>)<sup>2</sup>/Hz,
- Frequency 100 Hz: Accel. Spectral. Density: 0.04 (m/s<sup>2</sup>)<sup>2</sup>/Hz,
- Frequency 650 Hz: Accel. Spectral. Density: 6.0 (m/s<sup>2</sup>)<sup>2</sup>/Hz,
- Frequency 2000 Hz: Accel. Spectral. Density: 4.0 (m/s<sup>2</sup>)<sup>2</sup>/Hz,
- RMS value of acceleration: 90 m/s<sup>2</sup>,
- Duration of the test: 5 hours

The random vibration profile for transversal axis is presented in a diagram (Figure 6).

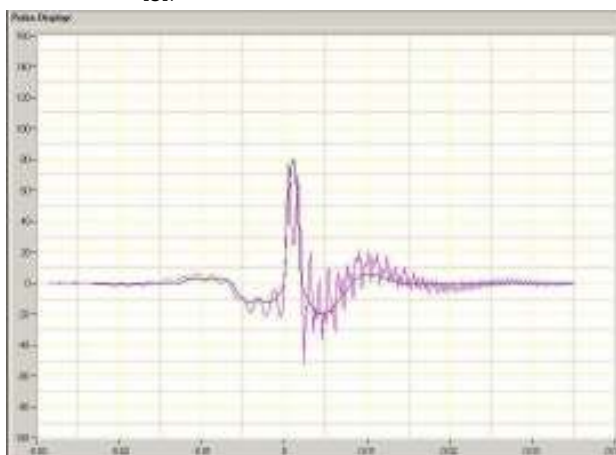
- Environmental temperature 23<sup>0</sup>C,
- Pulse shape-half sine,
- Acceleration: 800 m/s<sup>2</sup>,
- Duration of the pulse: 2 ms,
- Number of shocks 18: 9 shocks in two directions of the vertical axis

The shock parameters in positive and negative direction are shown in Figures 7 and 8 (x axis: time [s]; y axis: acceleration [g]).

Figure 7: Positive direction

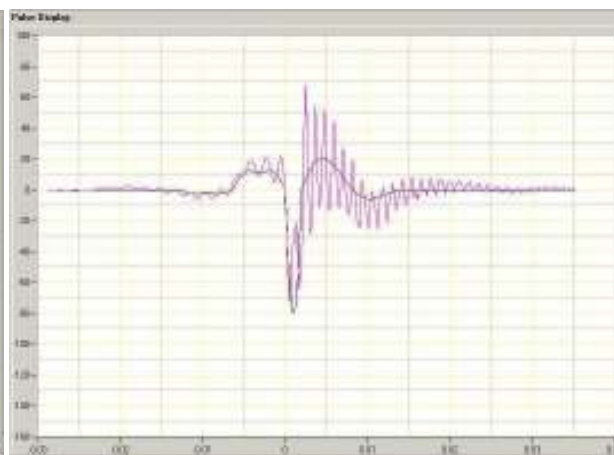
Figure 8: Negative direction

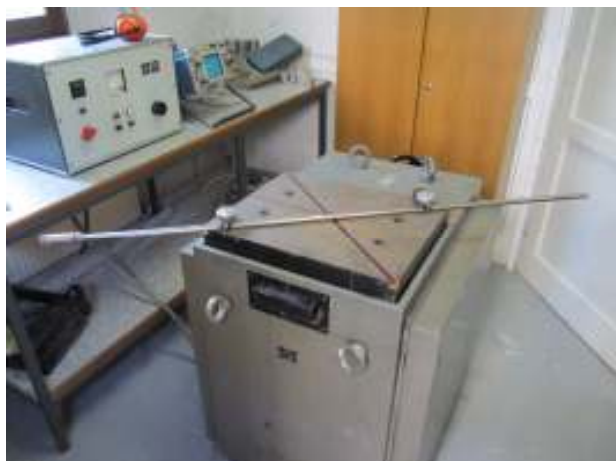
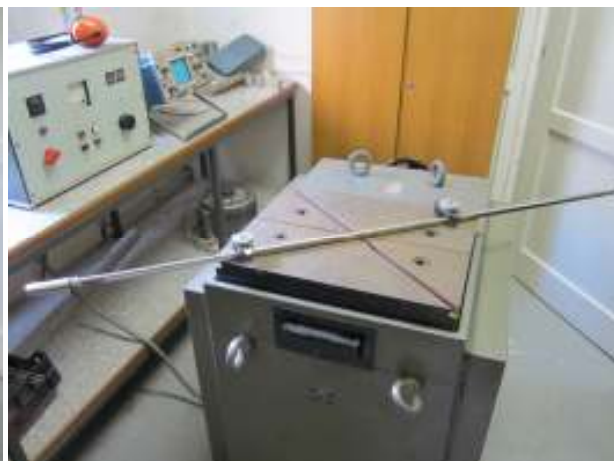
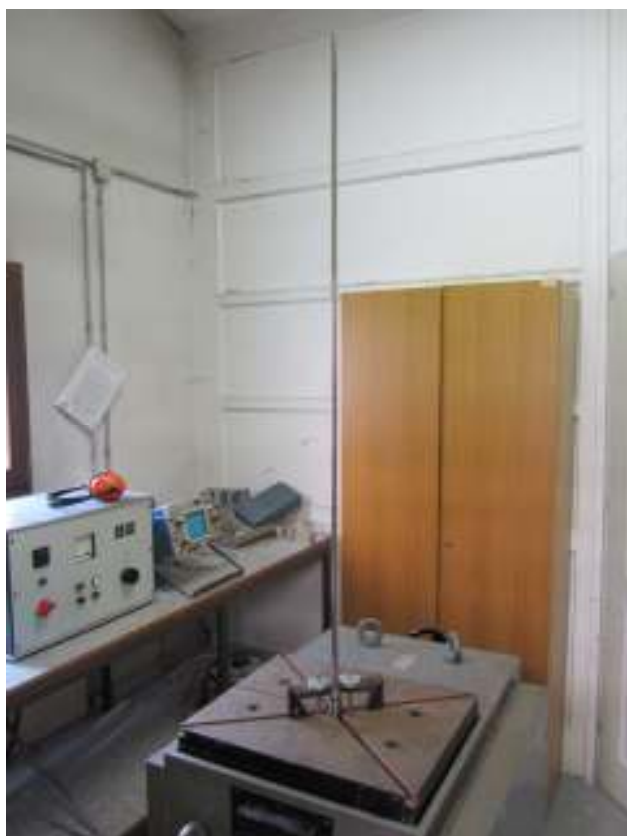
The fixation of the EUT on the shock machine Ravenstein in vertical, transversal and longitudinal axis is shown in Figures 9 to 11.

**Conclusion:** After the test no visible damages were observed. The impedance on the heater was measured. There was no change of impedance.

Figure 9: Transversal axis

Figure 10: Vertical axis

Figure 11: Longitudinal axis

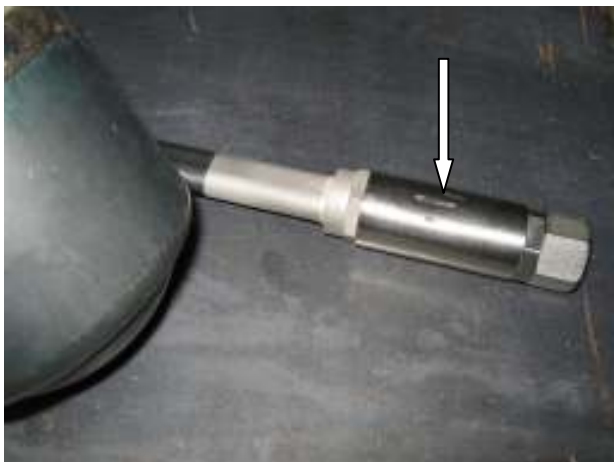
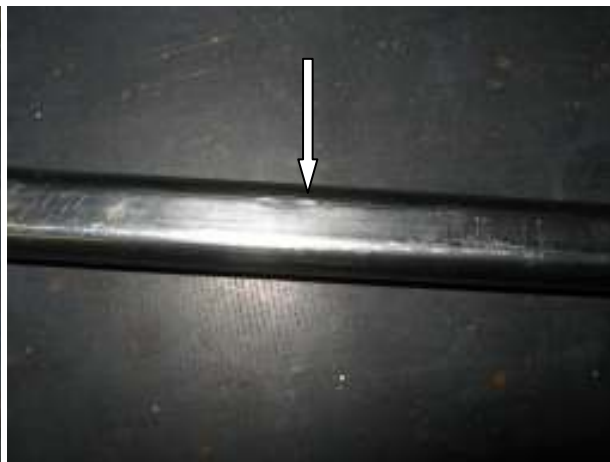
The testing hammer falls freely from a rest through specified vertical height onto the enclosure surface. The fall of the hammer is guided by the tube.

- Environmental temperature 23<sup>0</sup>C,
- Vertical height: 400 mm; Energy 20 J,
- Number of impacts: 5 evenly distributed on the face of the enclosure,
- Non-operating condition

**Conclusion:** After the IK 10 test there were no cracks observed on the enclosure. There were small plastic deformation of the metal housing but it has no influence on correct operation of the sample or impair safety (Figures 12 and 13). The impedance on the heater was measured. There was no change of impedance.

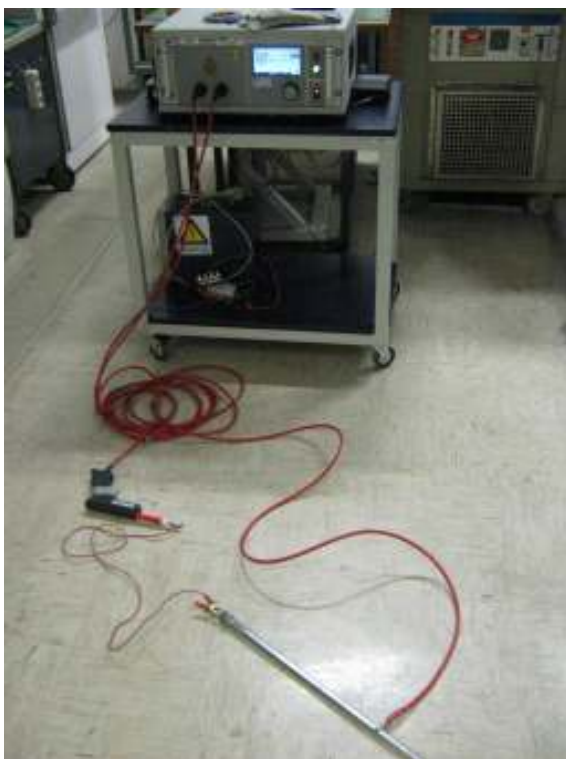
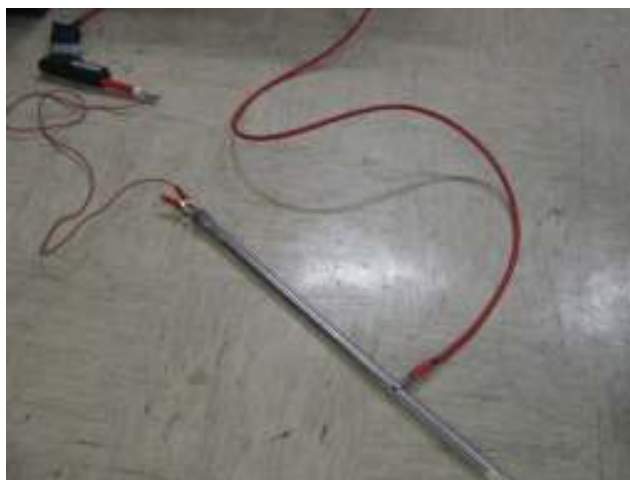
Immediately following the vibration, shock and IK10 test the dielectric strength test with 1250 V a.c. has been conducted between terminals and enclosure. The voltage was applied and maintained for a period of one minute between the points indicated (Figures 14 and 15). The test was passed successfully.
